# Home Report

25 Athol Terrace  
Bathgate EH48 4DN

# Single Survey

## Survey report on:

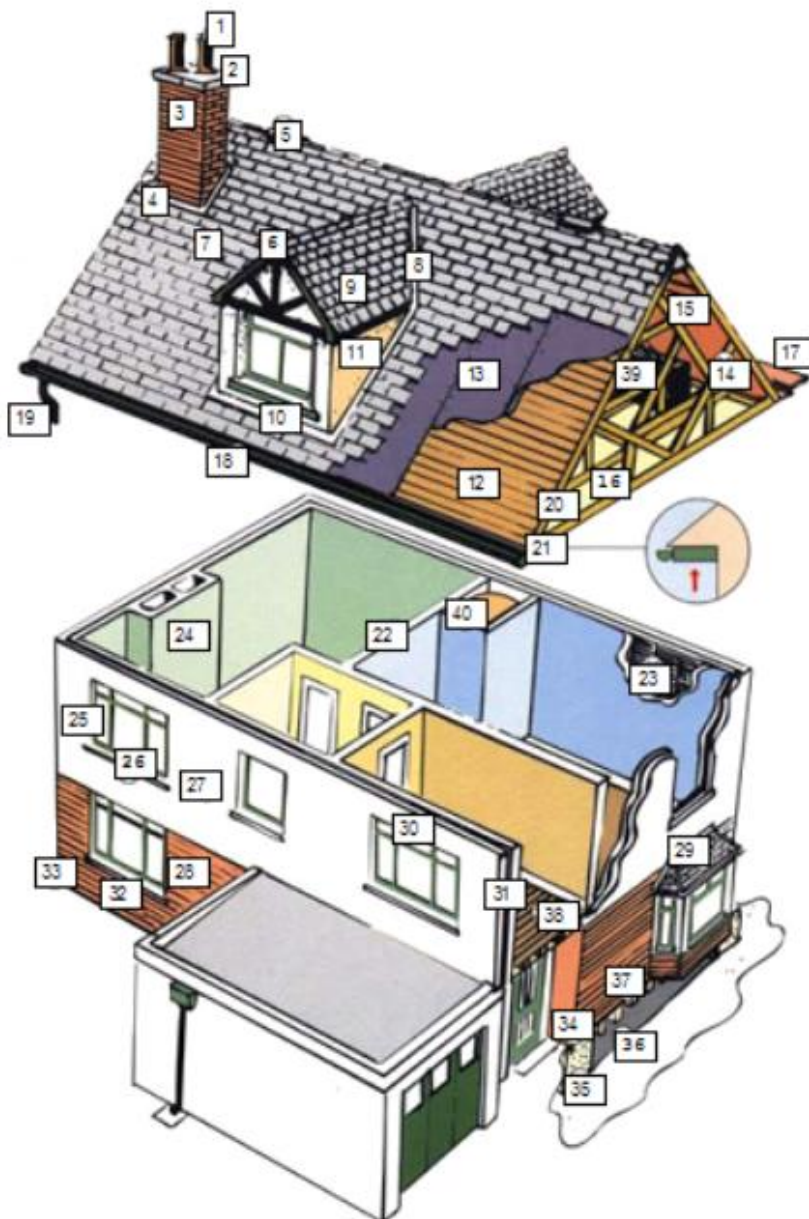
## Sectional diagram showing elements of a typical house

| 1 | Chimney pots |
| 2 | Coping stone |
| 35 | Foundations |
