# Home Report

# ENERGY REPORT

Dwelling Address	148 Foxknowe Place, LIVINGSTON, EH54 6TZ
Reference	008572
Assessment Date	24/04/2026
Submission Date	04/05/2026
Property Type	Semi-Detached House
Total Floor Area	70 m <sup>2</sup>

# Single Survey

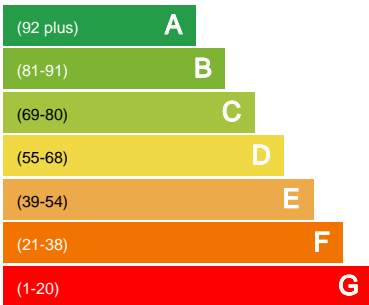
## Energy Efficiency Rating

Very energy efficient - lower running costs

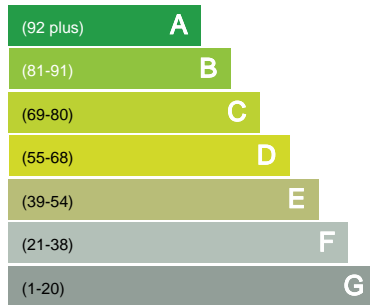
## Carbon Dioxide (CO<sub>2</sub>) Emissions Rating

Very environmentally friendly - lower CO<sub>2</sub> emissions
